# STANDARDS AND GUIDELINES

*for the Conservation of Historic Places in Canada*

Parks  
Canada

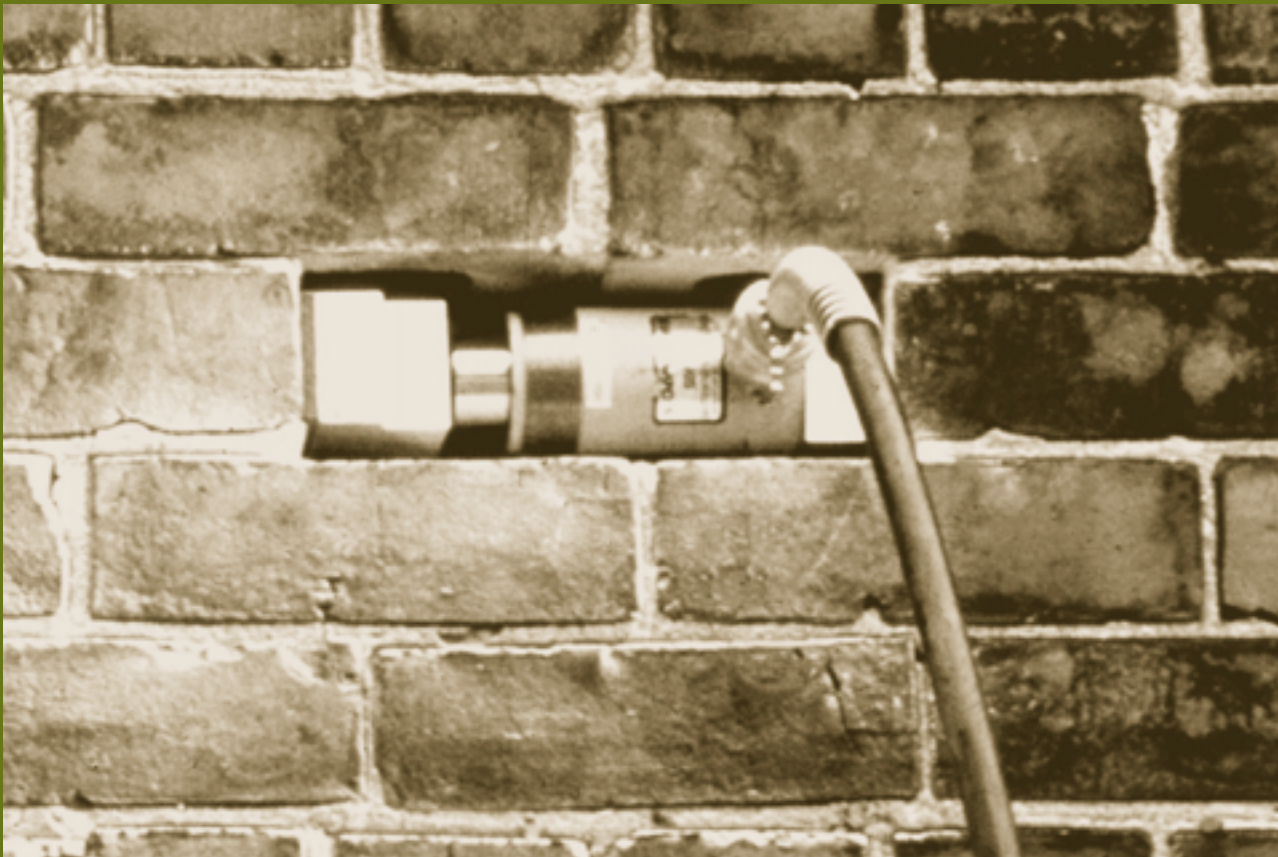
Minimally destructive testing techniques should be used to determine the strength of materials. For example, this in-place “push test” uses a calibrated hydraulic ram and a pressure gauge to measure the actual shear strength of a traditional brick wall, and thus its seismic resistance. A single brick beside the brick being tested is removed to accommodate the hydraulic ram (and is replaced in the wall after completion of the test).

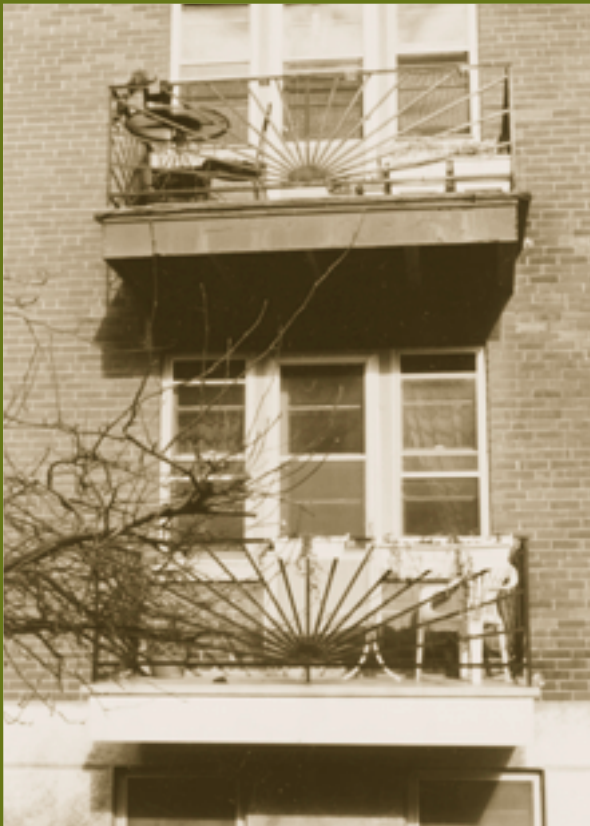
The long-term performance of many substitute materials is uncertain. This is why historic materials should be used wherever possible. Instead of repairing and repainting the wood elements of this character-defining balcony (original balcony above, altered balcony below), the existing wood structure was covered in metal and fiberglass cladding. The original colours that matched the remaining wood windows and details such as a drip moulding were lost. Materials that are considered “low-maintenance” are often used as new substitutes, although they may be less durable in the longer term.

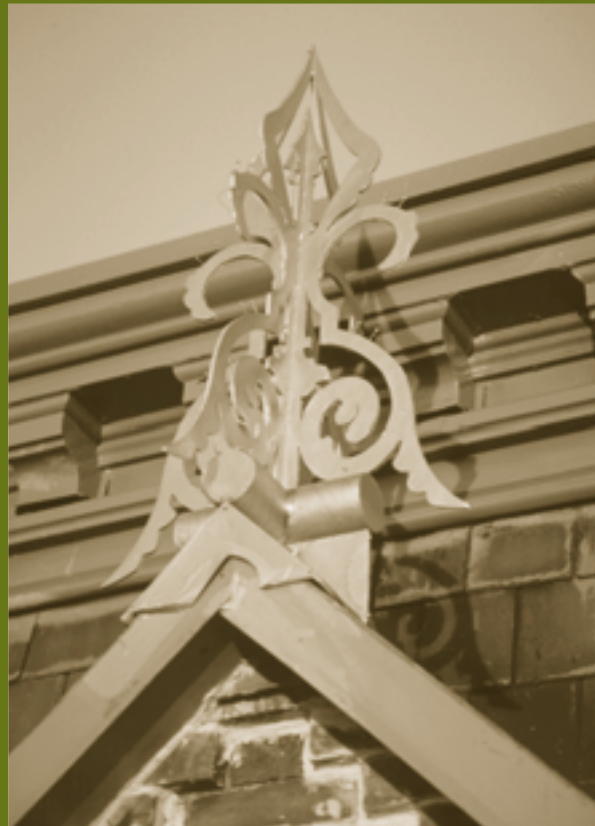
Under certain circumstances, substitute materials may be appropriate. As part of a *Rehabilitation* project, new finials were designed based on remains of originals. The originals were fabricated of wafer thin galvanized metal soldered together. The substitute material used in the new design was plate aluminum.

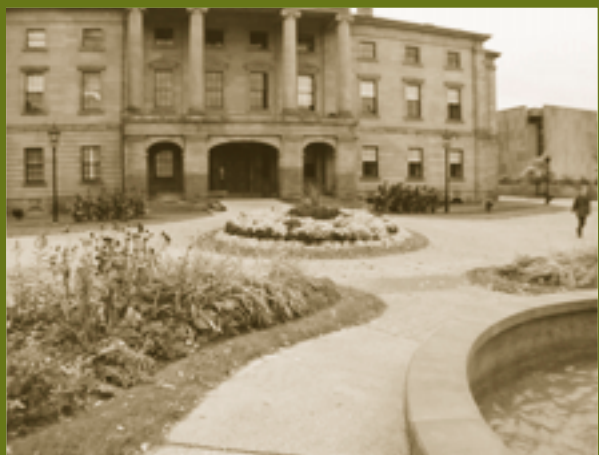
Alterations or new construction designed to meet requirements such as accessibility need to be carefully thought out in order to respect the character-defining elements of a historic place. Accessibility requirements at Province House in Charlottetown, Prince Edward Island were met by changing the slope in the grounds as part of the rehabilitation of the landscape in front of the main entrance. The change in grade is limited to the middle section of the building in order to preserve the view of the base course and the use of sections of the original steps.

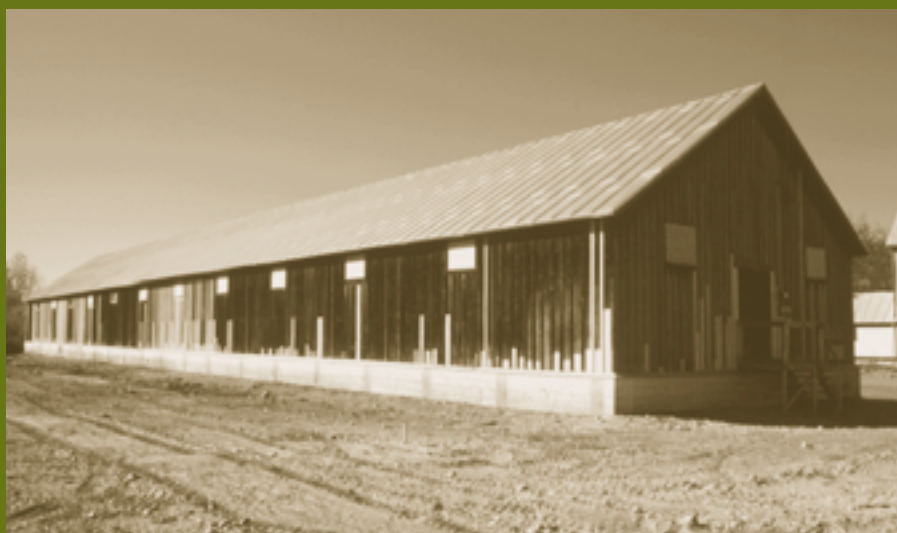
Maximizing the retention of character-defining materials and features is the primary goal of *Preservation*, as demonstrated in this photograph. Work on this wooden warehouse consisted primarily of minor repairs to the foundation skirting and limited replacement of deteriorated material. The new wood will be left to weather to the same appearance as the old.

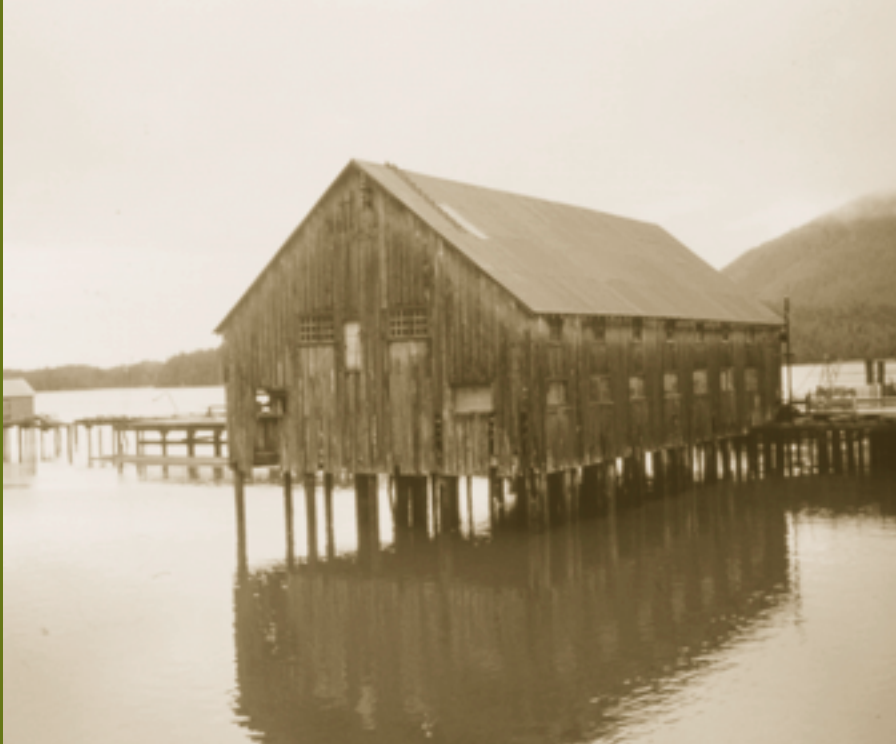
It is important to identify the cause of any damage to a wooden building element before beginning a *Preservation* treatment. In the case of the former machine shop of the North Pacific Cannery, exposure to marine conditions led to deterioration of the exterior wood cladding.

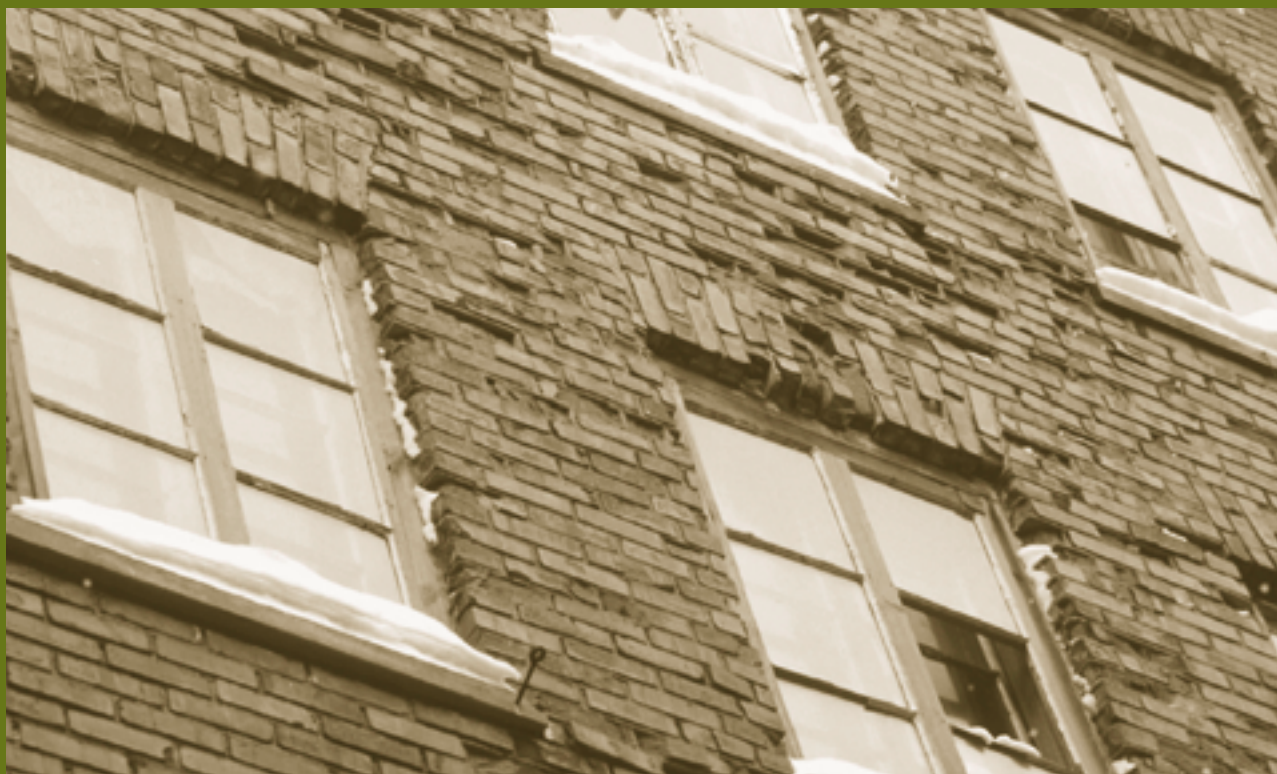
The harsh climate in many parts of Canada can seriously damage masonry elements. This wall in Quebec City has suffered irreversible damage from water penetrating the brick façade and freezing, causing the faces of many bricks to pop off. To avoid damage such as this, it is recommended that moisture penetration be stopped by repairing failed flashings, deteriorated mortar joints or other mechanical defects, not by applying water-repellent coatings, which can trap moisture inside the masonry.

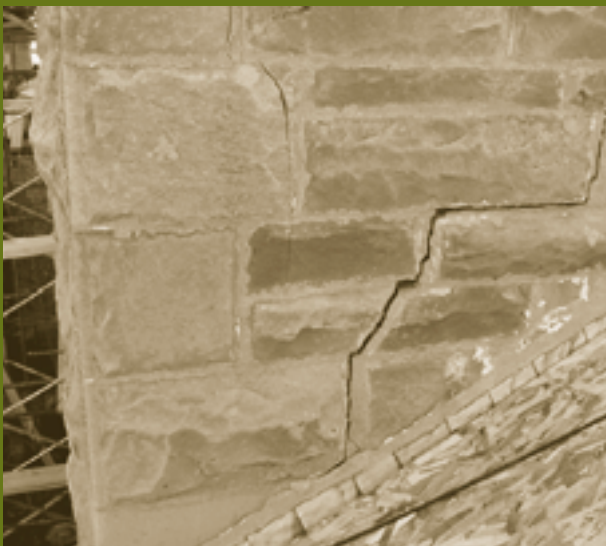
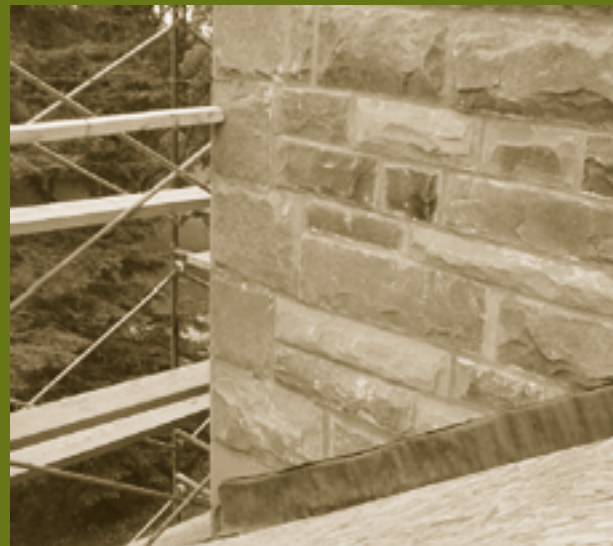
Deteriorated mortar joints in masonry walls should be repaired by repointing. The deteriorated mortar should be removed by carefully hand-raking the joints to avoid damaging the masonry, and the new mortar should duplicate the period mortar in strength, composition, colour, texture, width and joint profile. Repointing with mortar of high Portland cement content is not recommended, unless this was the historic mortar.

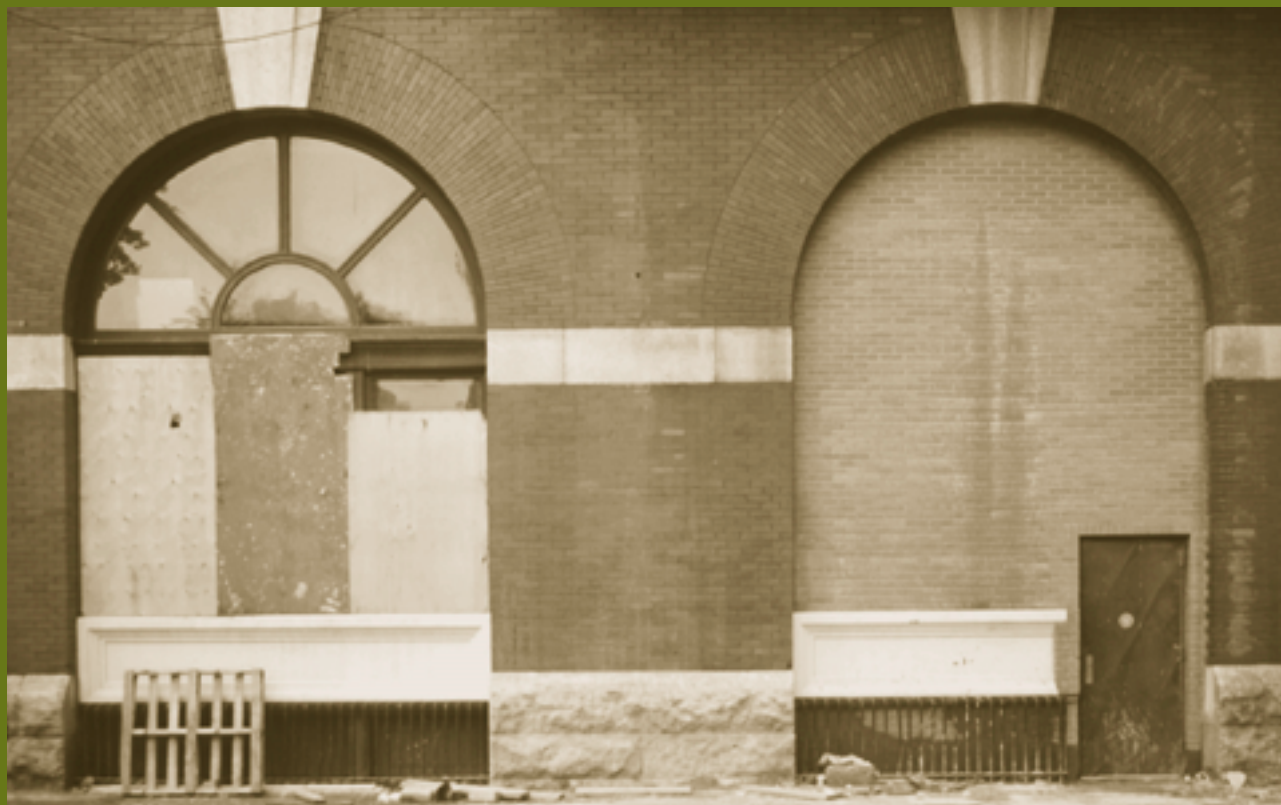
Cleaning masonry should be undertaken only when necessary to halt deterioration or remove heavy soiling. If surface cleaning is appropriate, tests using recognized preservation methods should be first be made in order to select the gentlest cleaning method possible, and be observed over time to determine the immediate and the long-term effects. The test-cleaning of the left portion of this brick and stone wall (using low pressure water and detergents, when there was no chance of freezing) created an acceptably clean wall.

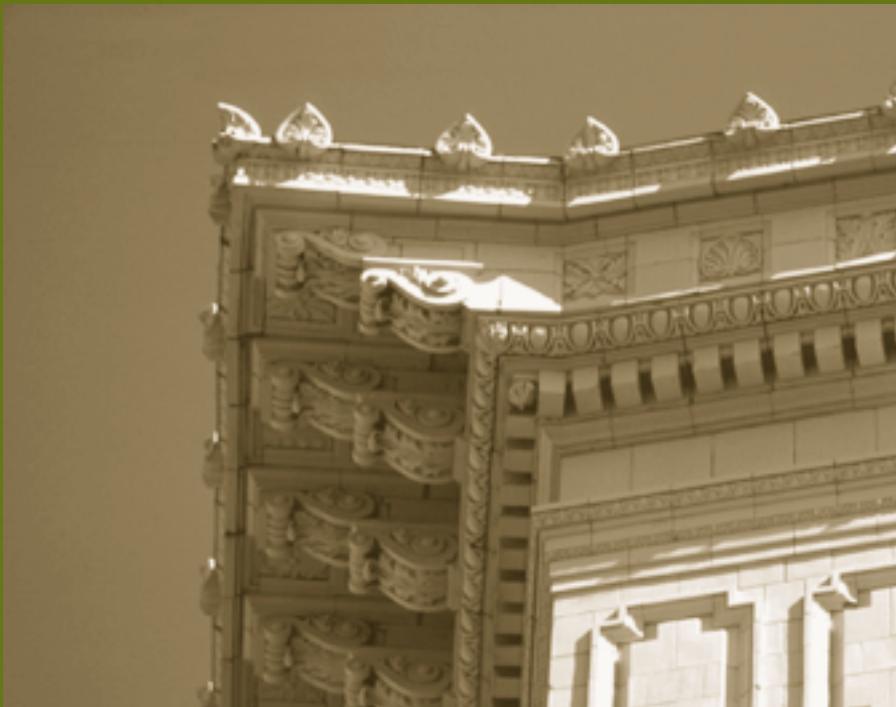
One of the primary causes of deterioration of glazed architectural terra cotta is water. Water-related damage to the glazed units, mortar, metal anchors or masonry backfill can be repaired only when the sources of that water have been eliminated. This typically means repairing flashing, repointing deteriorated mortar with a mortar that has a compressive strength lower than the adjacent masonry unit, and coating or sealing blistered spots to prevent further entry of water. Repointing with waterproof caulking compounds or the wholesale coating of the wall with waterproof materials will impede the normal outward migration of moisture through the masonry joints and likely cause spalling of the glaze or mortar.

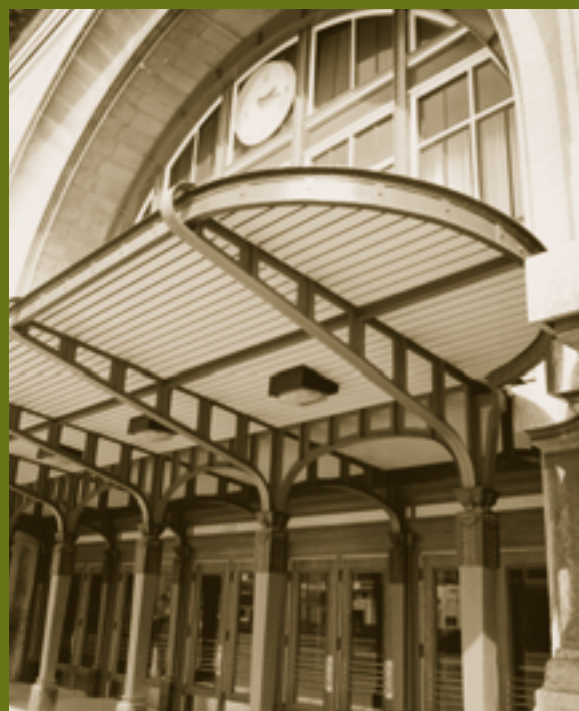
A regular programme of cleaning and re-applying appropriate paint has preserved to a remarkable degree the metal entrance canopy of Winnipeg's Union Station, which was completed in 1911. Protection from corrosion should be considered the first line of defence in preserving architectural metals.

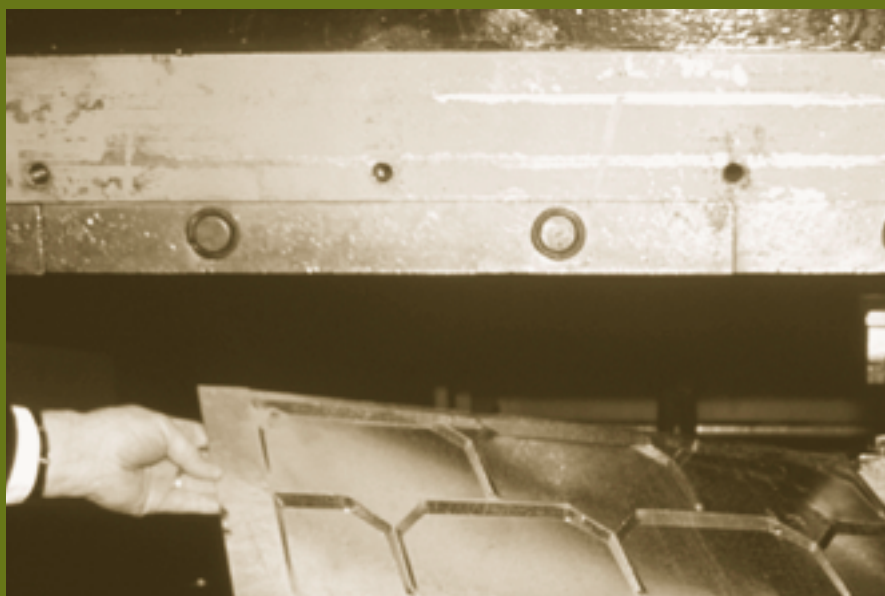
A surviving pressed metal shingle was used as a prototype for manufacturing replacement shingles for the *Restoration* of the main house at the Motherwell Homestead near Abernathy, Saskatchewan. As a rule, in *Restoration*, repairs or replacements of extensively deteriorated or missing parts of features are done in kind, and are based on physical, documentary and oral evidence.

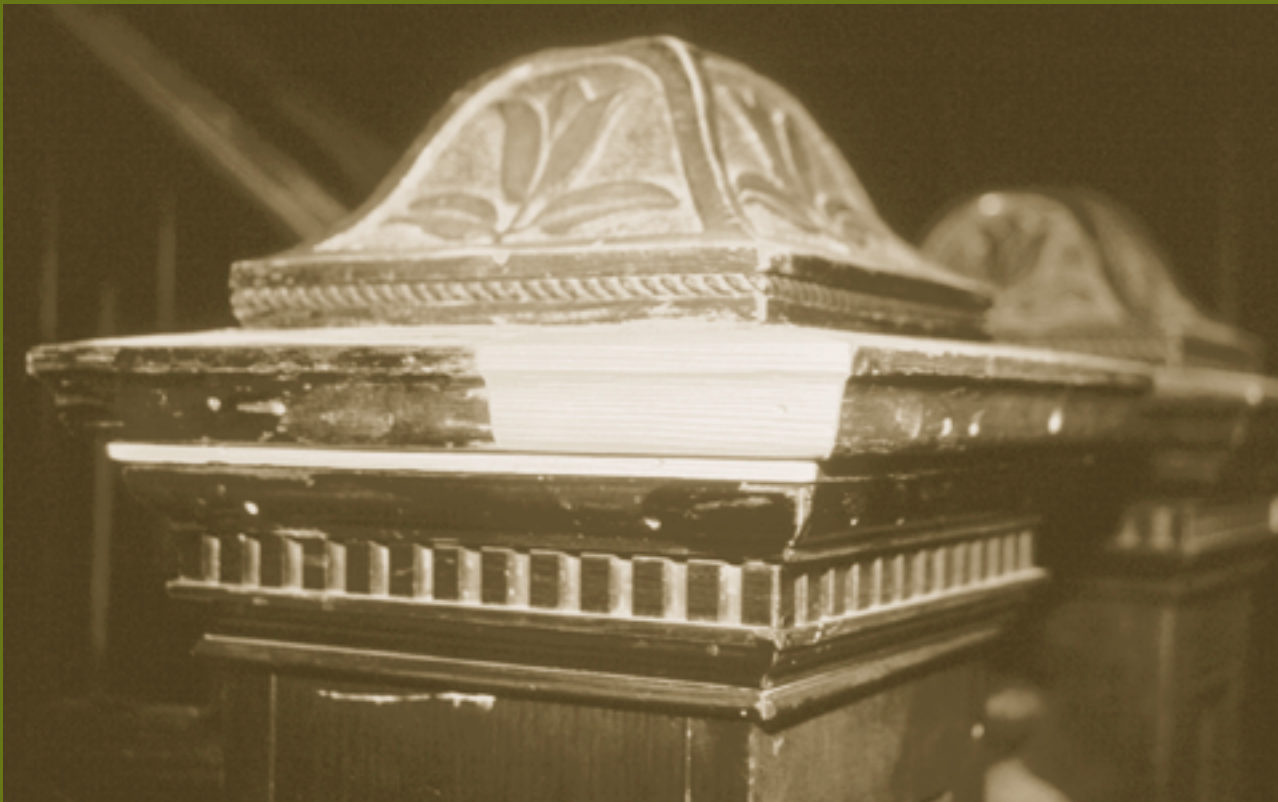
An example of “limited replacement in kind” points out an appropriate scope of work within the treatment *Preservation*. Only the damaged corner of a stair’s newel post has been replaced- (it will be stained to match). Targeting repairs to the deteriorated elements meant that most of the character-defining elements were retained.

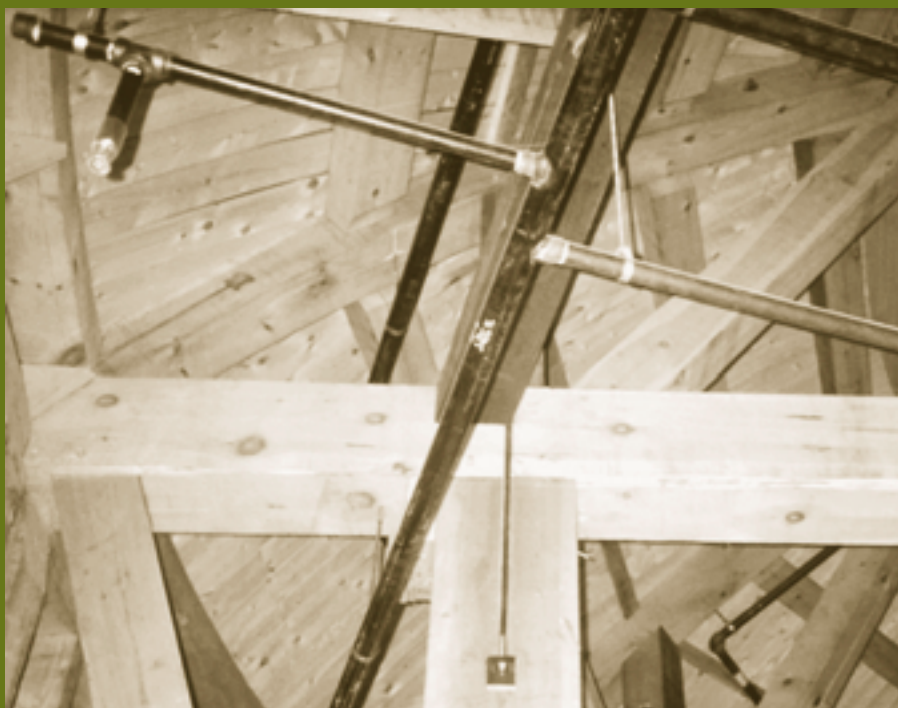
New mechanical systems should be installed in a way that results in the least alteration possible to the building. In the *Restoration* of St. George's Anglican Church, Halifax after a devastating fire, care was taken to ensure that the character-defining structural system and interior features from the restoration period were not altered or obscured when a new fire-suppression sprinkler system was installed in the attic.

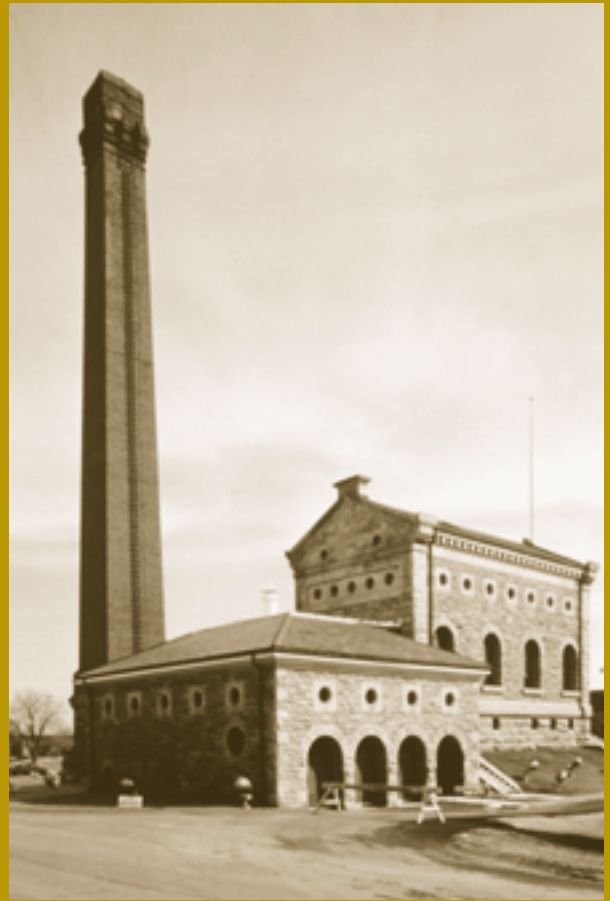
The Hamilton Waterworks, built in 1857-59, is the only intact mid-19<sup>th</sup> century waterworks in North America. The character-defining compound-beam steam pumping engines were restored to working condition in 1998.

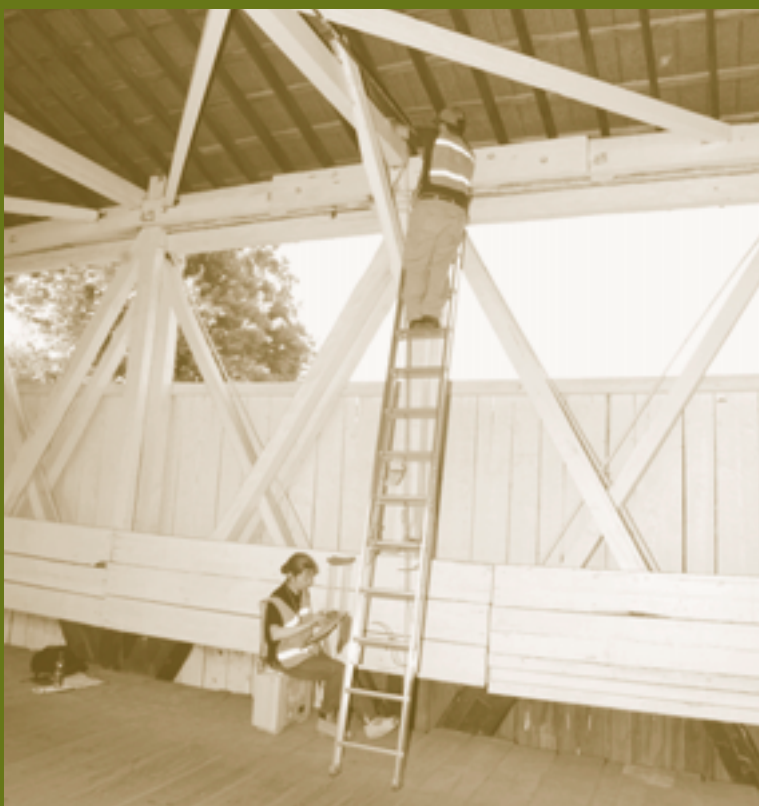
Prior to beginning project work, the form, materials and condition of engineering works should be documented. Heritage recording of the Percy covered bridge, National Historic Site of Canada in Powerscourt, Quebec, the only surviving bridge that uses the McCallum inflexible arch construction, included detailed measurements and a photographic record.
